May 27, 2022

# Study and Design of Correctional Center for Women

Mass. State Project No. DOC2106

Existing Conditions Documentation and Analysis

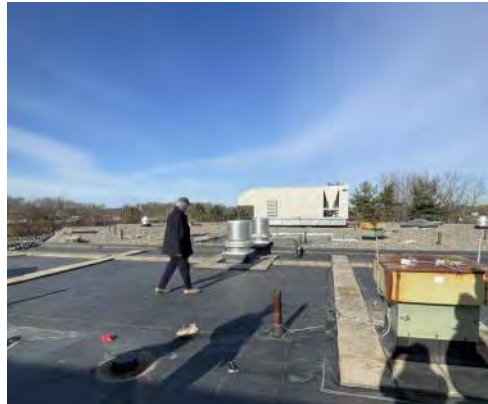
Figure 1.3.1.1 Betty Cole Smith roof types over the Housing Units<sup>3</sup>

Several roofing types exist on this building. On the northern wing of the housing units and over the most southern wing (above the intake and administrative areas), ballasted roofs are likely to be original to the building. It has received patchwork repairs over the years on an as-needed basis, but could benefit from a new roof. On the southern wing of the housing units, a new ethylene propylene diene monomer (EPDM) membrane was installed, likely around the time the new air handler units were replaced (See Figure 1.3.1.1). A gable roof over the entryway is comprised of a prefinished standing seam metal panels placed in a gable configuration.<sup>1,3</sup>

Water infiltration and roof leaks have been reported at this building. Further on-site observations and/or spot probing may be required to observe if and the extent of how any water and moisture infiltrations may have impacted the existing structure.

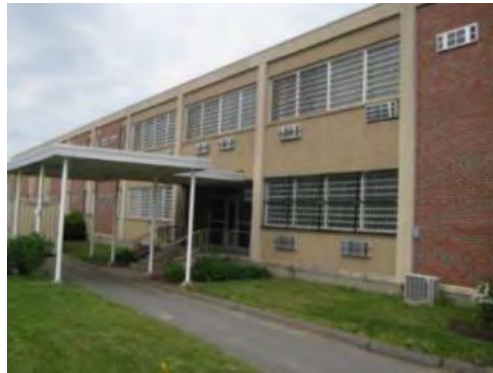
Figure 1.3.2 Infirmary Building <sup>7</sup>

The building's roofing system consists of a single-ply ballasted EPDM membrane with internal draining.<sup>2</sup> More analysis of this internal draining system will be required to determine if any blockage or leakage has developed.<sup>1</sup>

The existing steam pit, located on the southeast reentrant corner of the building, does an efficient job with melting snow around the building, however, it the resulting water infiltrates and floods the building, which is problematic. Further investigation on the flooding and ponding will need to be made to determine the effects it may have on the structural integrity.<sup>2</sup> There are known leaks in the basement as well as through poorly caulked single-glazed, brushed stainless steel window assemblies. Doors are primarily painted steel panel assemblies.<sup>2</sup>

The Infirmary Administration Building is equipped with a radiant heating water system<sup>2</sup> which is fed off the steam system. The building has de-centralized through-wall heat pumps for cooling that are in need of replacement.<sup>3</sup>

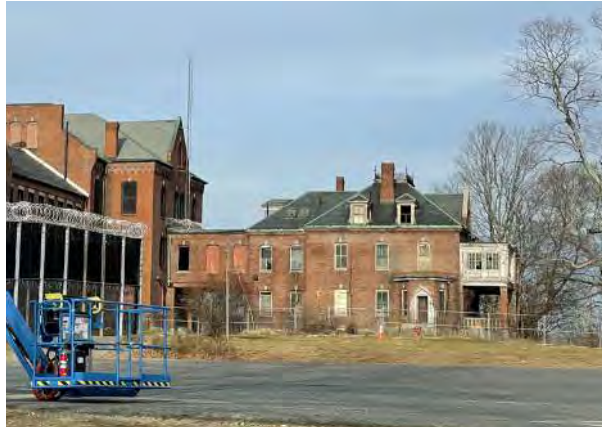
Figure 1.3.6 Old Superintendent's House fenced off<sup>3</sup>

The Design Team was not able to walk through the building as it is fenced off. All observations were made from a distance. Due to the safety concerns of accessing the building and its significant deterioration, it is likely that the Old Superintendent's Building is unsuitable for adaptive reuse.<sup>1,3</sup>

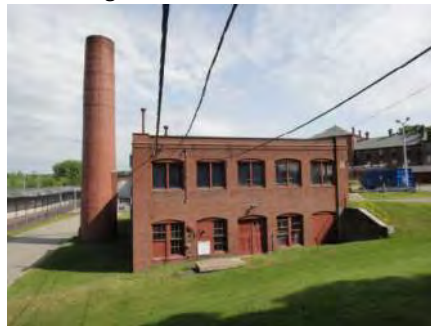
Figure 1.3.10.1 Power Plant <sup>4</sup>

Due to extensive deterioration and weathering, the large brick chimney has been leaning towards the eastern direction at a rate of 2 centimeters per year. It is currently held in place by wood bracing and wiring (Figure 1.3.10.2). The chimney, which is in poor condition and has the potential of falling on the Power Plant, has been recommended for demolition by the Faithful + Gould 2020 FCA Study; this recommendation was visually confirmed during the site visit.<sup>3</sup>

The chimney is a prominent visual feature to the campus and may not be one that the Massachusetts Historic Commission (MHC) will allow for demolition without proper reasoning. Based purely on assumptions, the MHC may require the Design Team to explore a more robust means of stabilizing the existing condition.

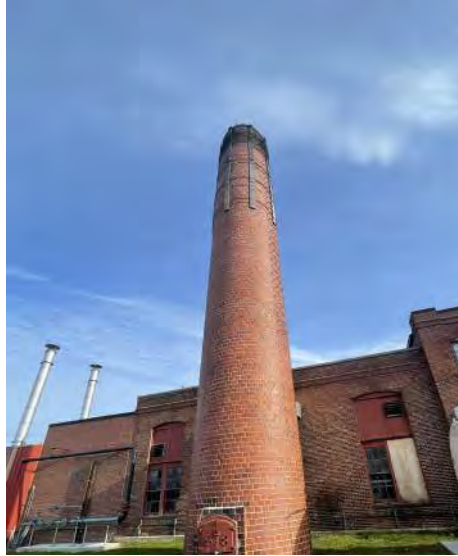
Figure 1.3.10.2 Power Plant - Top of chimney braced by wooden slats and metal wiring<sup>3</sup>

Active moisture infiltration issues has been reported. Additionally, the concrete foundation has deteriorated and has been documented.<sup>1</sup>

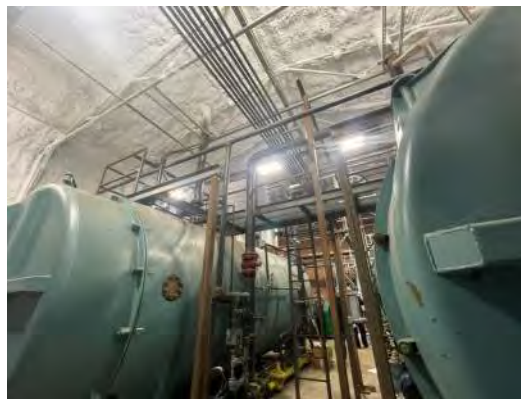
Figure 1.3.10.3 Power Plant - New Boiler Room addition<sup>3</sup>

Recently, a new structure was placed north of the existing Power Plant that houses the two new boilers that will phase out the existing 1959 and 1962 oil-burning boilers (Figure 1.3.10.3). This structure is a corrugated metal structure supported by metal trusses. With the exception of one side where this structure meets the existing Power Plant's exterior wall, the interior walls and the underside of the roof structure contain spray foam insulation.

More investigation needs to be made on the connection between the new boilers' housing structure and the existing Power Plant structure.<sup>3</sup>

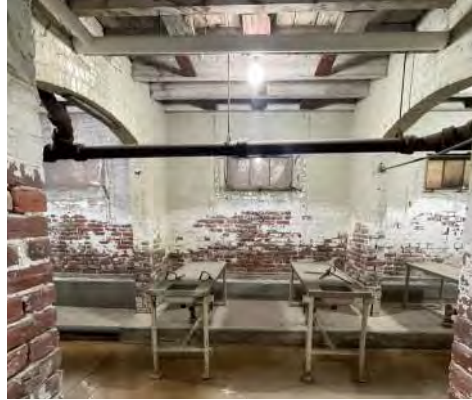
Figure 1.4.7d Antiquated & abandoned Health Services beds from the 1800s<sup>3</sup>

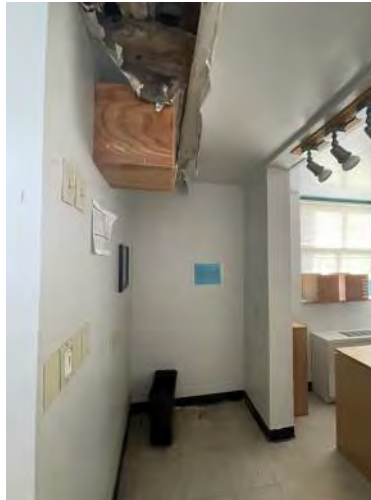
Figure 3.6.3 Damage and paint peeling from Intake Area<sup>12</sup>

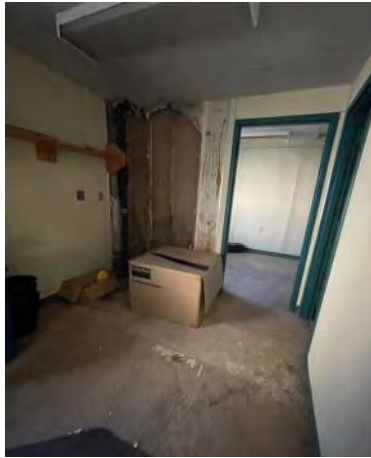
Figure 3.6.6 Water damage located on the walls and floors of Office<sup>12</sup>
