May 27, 2022

# Study and Design of Correctional Center for Women

Mass. State Project No. DOC2106

Existing Conditions Documentation and Analysis

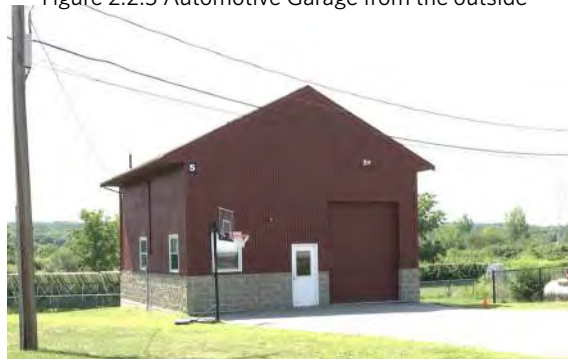
Figure 2.2.3 Automotive Garage from the outside <sup>8</sup>

This garage is a wood-framed structure comprised of prefabricated wood roof trusses, wood joists, and stick built wood walls. The structure sits on continuous footings with a split face concrete masonry unit foundation wall. The structure appears to be in good condition but should be evaluated if this building becomes a viable option for repurposing.<sup>6</sup>

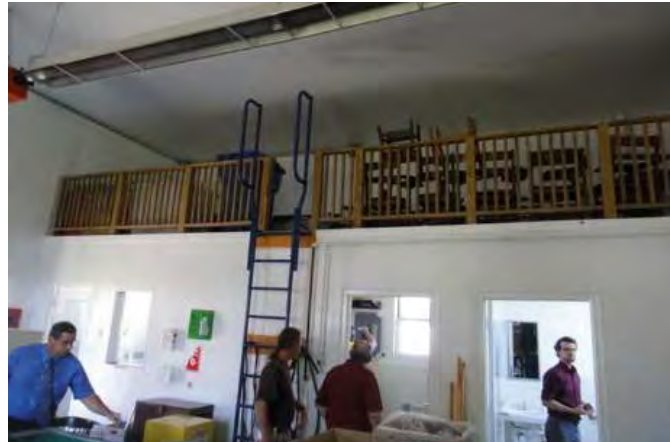
Figure 2.3.3 Automotive Garage <sup>9</sup>

The building was never utilized for its intent. It was originally programmed to function as a vocational space but was utilized as a storage space, and then later a classroom before being vacated.<sup>1</sup> (Figure 2.3.3) Unfortunately, its underutilization is the primary reason why upgrades to ventilation, etc., were never formulated.

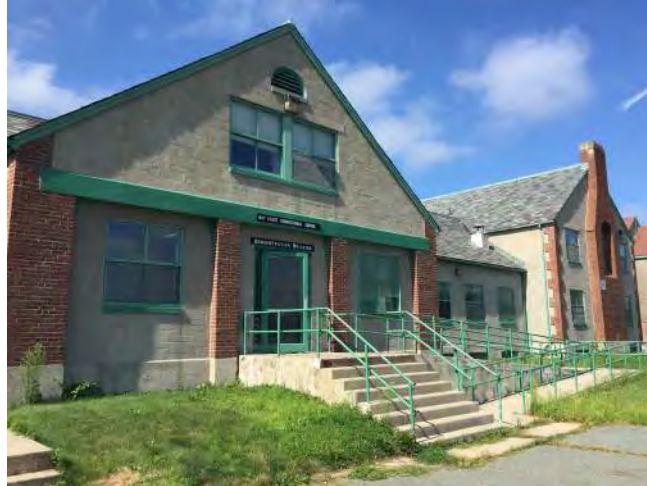
Figure 3.2.3 Administration Building <sup>8</sup>

This 1934 building was created on conventionally reinforced concrete framing, formed reinforced concrete elevated slabs, and concrete masonry shear walls. The interior columns are founded on isolated concrete spread footings, and the exterior walls are founded on continuous spread footings.<sup>7</sup> Currently, there are no known and/or outstanding issues with the structural system,<sup>1</sup> but this should be confirmed by a structural engineer's analysis to determine if this building is suitable for reuse.

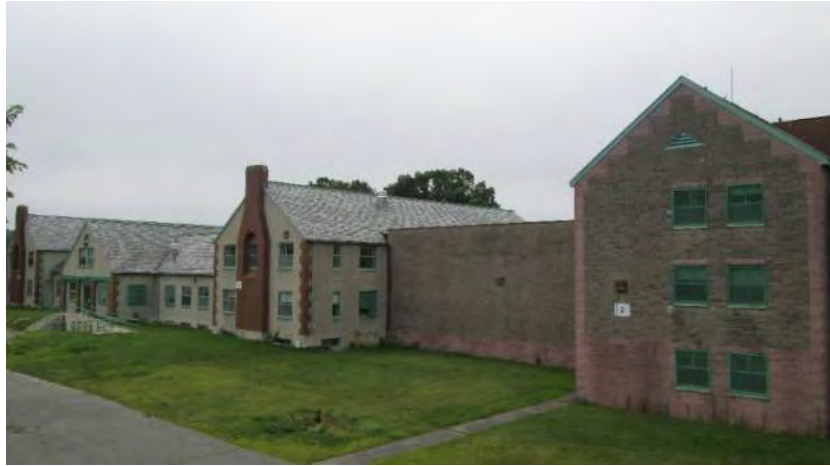
Figure 3.2.4 Administration Building (left) and the Main Building addition (right)<sup>11</sup>

This structure consists of reinforced concrete masonry and precast concrete elevated slabs. Both the interior and perimeter masonry walls are supported on continuous footings. They appear to be in good condition.<sup>11</sup> However, due to reported leaks and moisture issues, the structural system should be assessed by the Design Team if the building is repurposed.<sup>1</sup>

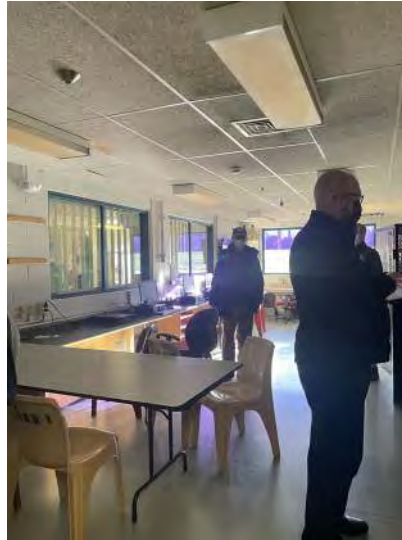
Figure 3.3.1.1 Training area in the Gate House <sup>12</sup>

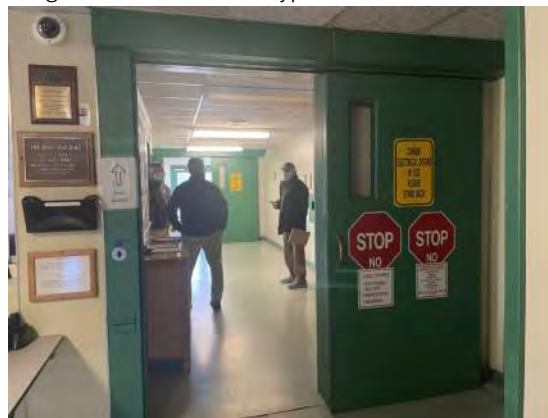
Figure 3.3.1.2 Internal sallyport in the Gate House <sup>12</sup>

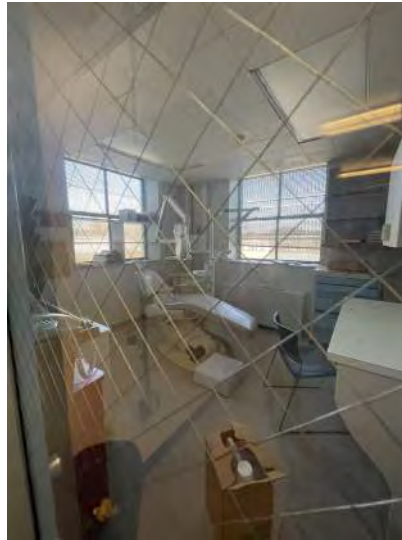
Figure 3.3.3.1 Dental Office on the First Floor<sup>12</sup>

- Replace the cabinetry inside the four exam rooms and dental offices in the HSU with ADA-compliant cabinets;
- Provide an adjustable height exam table in the Exam Rooms;

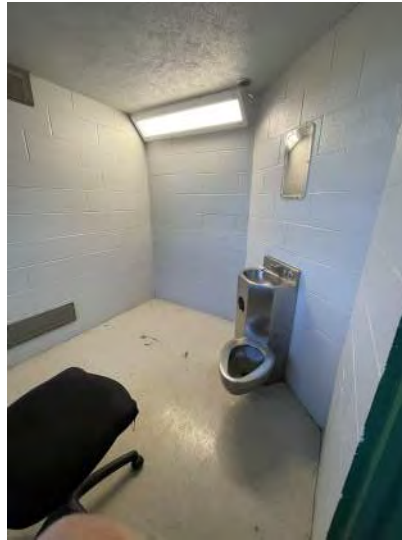
Figure 3.3.3.2 Holding Cell in the Intake Area <sup>12</sup>

- Modify the existing counter to accommodate for an accessible service counter;
- Replace the combi-unit inside the holding cell on the First Floor to accommodate a new ADA compliant combi-unit;

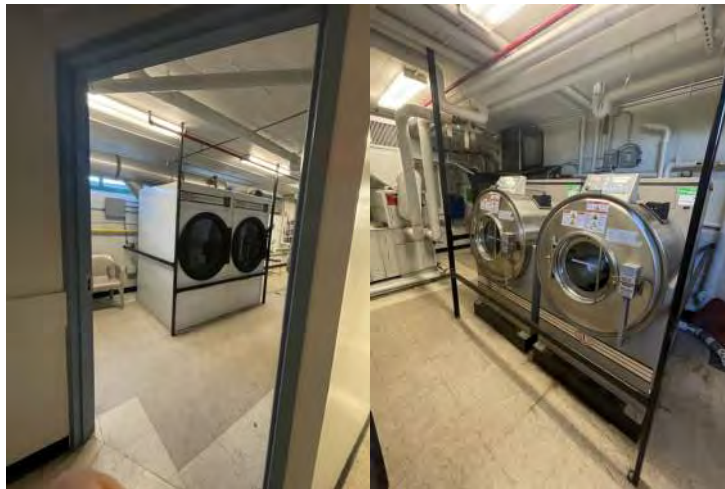
Figure 3.3.3.3 Laundry facilities in the Basement <sup>12</sup>

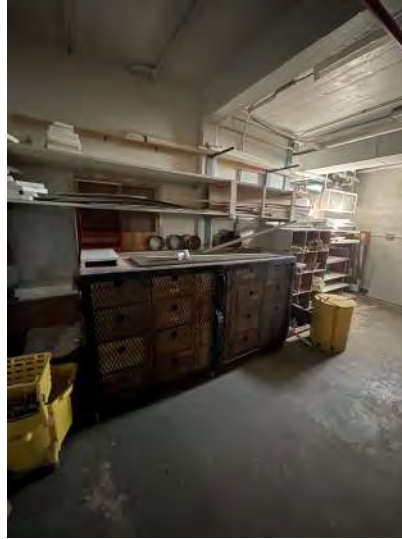
Figure 3.3.3.4 Basement Office Area<sup>12</sup>

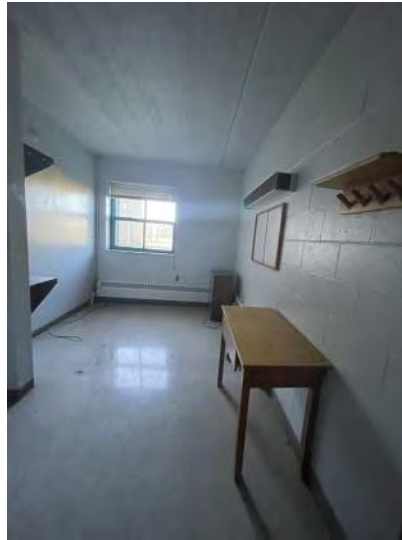
Figure 3.3.4 Typical hard cell located in the Main Building<sup>12</sup>

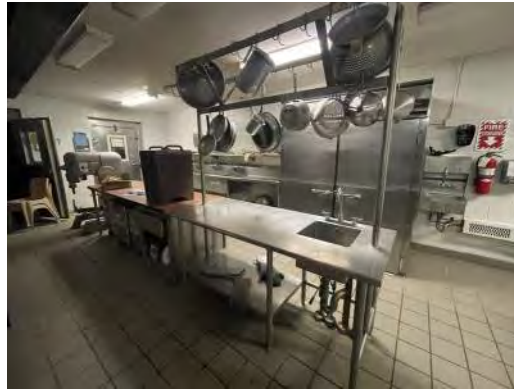
Figure 3.3.5.1 Kitchen<sup>12</sup>

The existing kitchen equipment was purchased in 1986 and 1991 with some additional components purchased in 1992.<sup>15</sup>

The hoods look to be original and are therefore no UL listed and non-compliant. The hood would need to be replaced to meet recent code updates and requirements.

The walk-in refrigerator and freezers appear to need cosmetic updates. If the building is to be reused, it would require the Design Team to assess for inefficiencies such as air leakage, mechanicals, and refrigeration performance. The recommendation is to have the units tested and if the construction (walls, floors, and ceilings) is in good shape, seal gaps if needed, and only replace the refrigeration components (lines, condenser, evaporator) to newer, energy efficient units.

Given that most of the equipment is beyond twenty years old and either at or reach its useful life, the general recommendation is to remove and replace the equipment with new energy efficient and modern units as they will be beyond life expectancy if the building is reused. If any equipment is desired to remain it would need to be tested to ensure it is performing adequately.

A general recommendation on the cookline would be to remove fryers and open burners in favor for other equipment that can meet the dietary demands required and not pose a significant safety risk.<sup>1,12</sup>

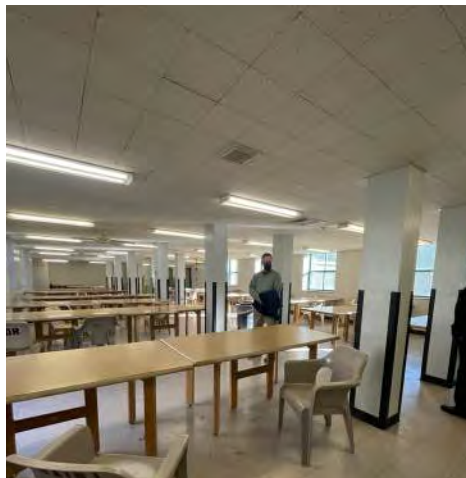
The DOJ's dining space requirement is 12-15 square feet per inmate, which, at 200 inmates, would equate to approximately 2,400 - 3,000 square feet. No plans of the space exist, however, based on the December 16, 2021 site visit, photos indicate that there may adequate space (Figure 3.3.5.2). However, room measurements will be required to verify the size of the space if this building is utilized for reuse.<sup>12</sup>

Figure 3.3.5.2 Dining Room<sup>12</sup>

Based on photos from the previously mentioned site visit, it appears that the space is in good condition - this visual assessment includes finishes and equipment.<sup>12</sup>

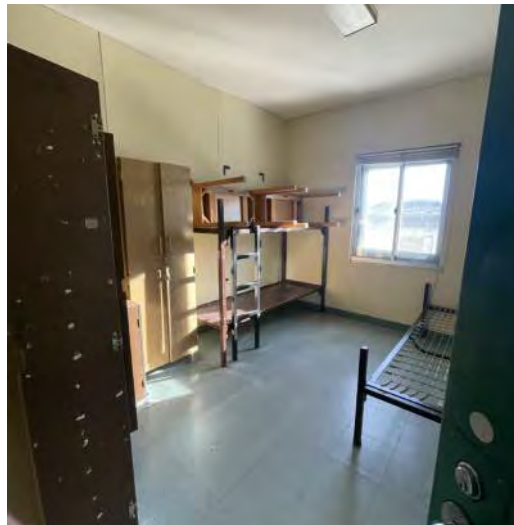
This L-shaped building was utilized to house the influx of inmates in the early 1990s. The rooms were relatively large and could fit two beds, but likely contained a mix of single and bunk beds. Closet units were also provided for each person in the cell. Toilet and sink (combi) units were not located in the rooms (Figure 3.3.6).

Figure 3.3.6 Typical Inmate Cell in the Modular Housing<sup>12</sup>

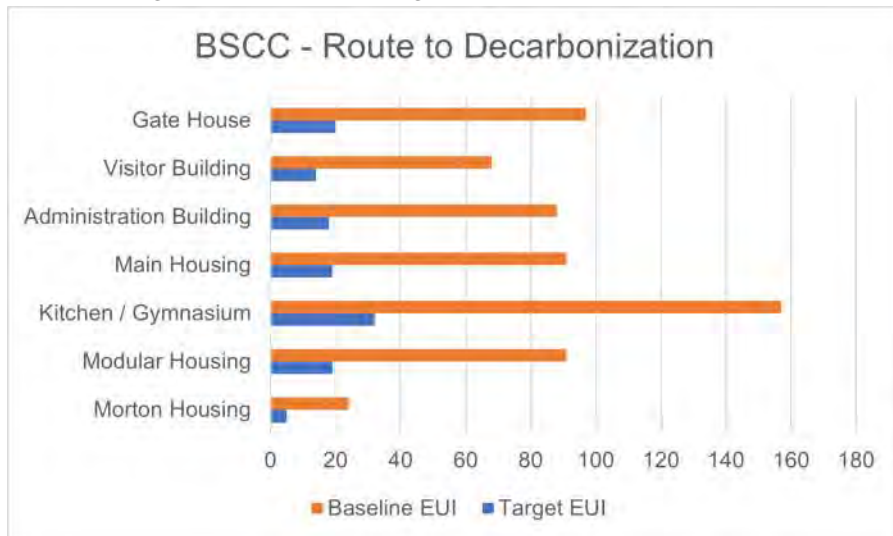
In efforts to work towards achieving Massachusetts Executive Order 594: Leading By Example: Decarbonizing and Minimizing Environmental Impacts of State Government, the use of AIA2030's ZeroTool to provide baseline and target Energy Use Intensities (EUIs). The baseline energy and emission metric is based on CBECS 2003/RECS 2001, but normalized by climate, weather, space type, building size, occupancy, and schedule, as noted on the AIA2030's ZeroTool website. Information such as Annual Energy Purchased and Annual Energy Generated are not factored into this calculation due to lack of information, but the calculations can be adjusted to include them once its known. In order to achieve a carbon neutral building by 2030, the building would currently require an 80% reduction in the baseline. As seen in Figure 3.5.1, any building repurposed will require significant changes to reach decarbonization.

Figure 3.5.1 Baseline and Targeted EUIs towards Decarbonization
